Manhole Inspection Summary

Manhole # S07GG2006MH

Insp Date: **7/6/06 10:23 AM**

Location Address: **2410 SHELLEYDALE DR**

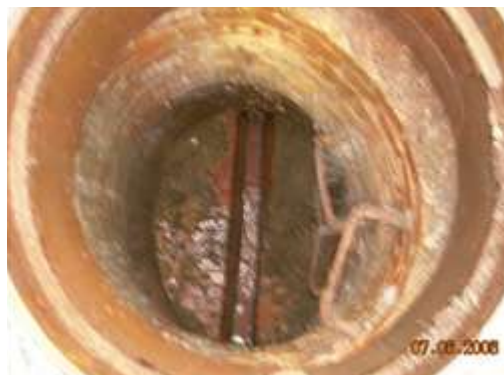
Top View

bench debris, frame leak, adjustment infiltration

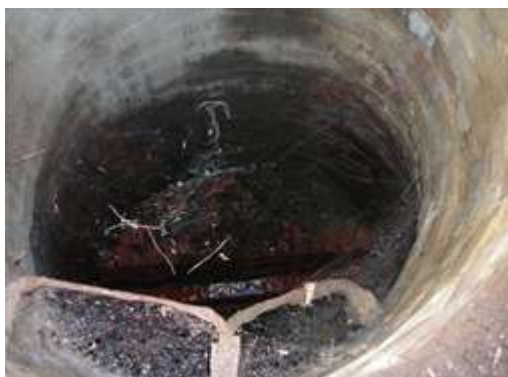
Defect

corroded steps, Corbel and barrel infiltration

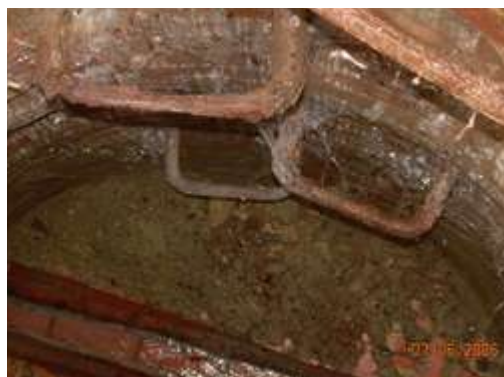
Defect

corroded steps, bench debris

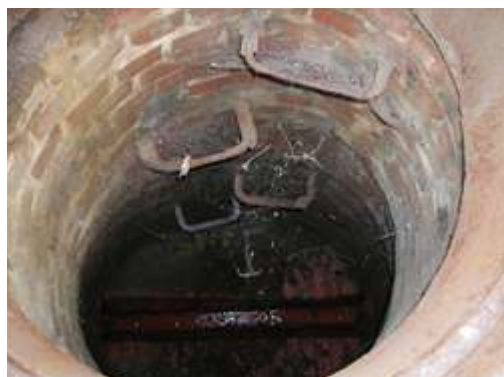
Defect

corroded steps, adjustment and corbel infiltration

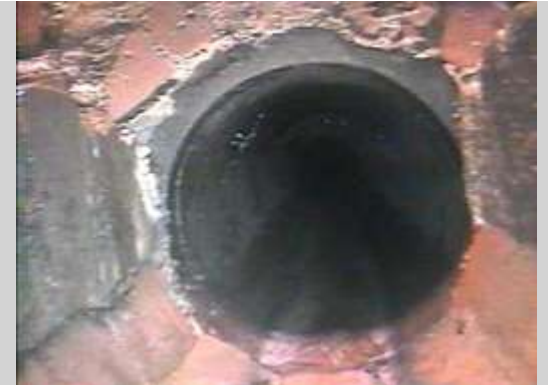
8 in. Circular Gravity Sewer Pipe Out @ 12 O'Clock

Pipe Material: **Clay** ☐ Pipe Lined

Invert Depth: **8.49** (ft.) Flow Characteristics: **Fast**

Deposits: ☒ None ☐ Mud ☐ Sludge ☐ Debris ☐ Grease

Infiltration: **None** Pipe Seal Cond: **Unknown**

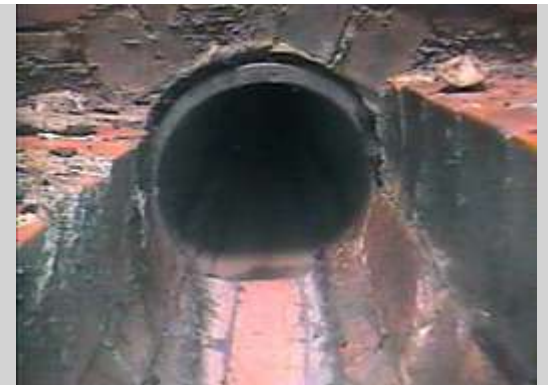
8 in. Circular Gravity Sewer Pipe In @ 6 O'Clock

Pipe Material: **Clay** ☐ Pipe Lined

Invert Depth: **8.23** (ft.) Flow Characteristics: **Fast**

Deposits: ☒ None ☐ Mud ☐ Sludge ☐ Debris ☐ Grease

Infiltration: **None** Pipe Seal Cond: **Unknown**
